REPORT

on thermal survey findings for the residential apartment block No. 234, building 3, located at prospect Krasnoi Armii, in the city Sergiyev Posad.

Table of content

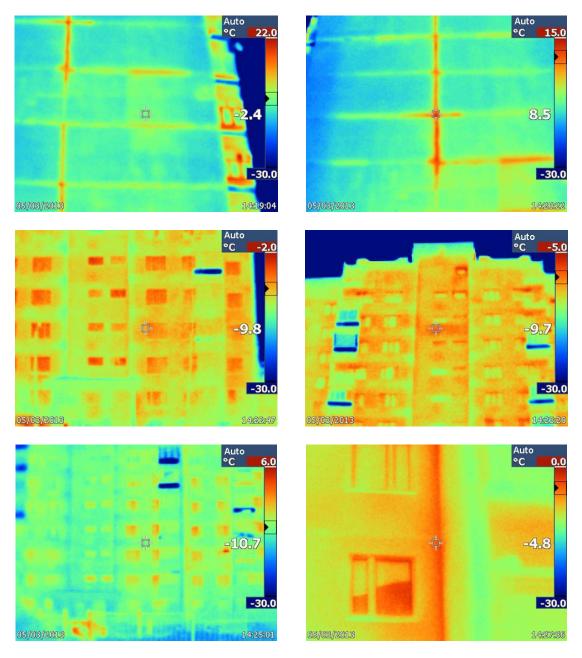
Thermal imaging survey data as of 05 March 2013. Outdoor air temperature is minus 20 °C.

The present survey was initiated by multiple residents' applications and complaints to low air temperatures in the apartments and condensation on indoor exterior wall during the heating season.

Thermal survey findings (Appendix 1) were used to calculate the actual building enclosing structures heat transfer resistance. Averaged wall external surface temperature is applied as the calculation input parameter.

Wall external surface temperature is assumed to be equal to minus 10.7 °C.

Surveyed building enclosing structure design heat transfer resistance is 1.51 m² °C /W.

Surveyed building enclosing structure actual heat transfer resistance is maximum 0.90 m² °C /W.

Surveyed building does not meet the sanitary regulations, all enclosing structures require winterization.

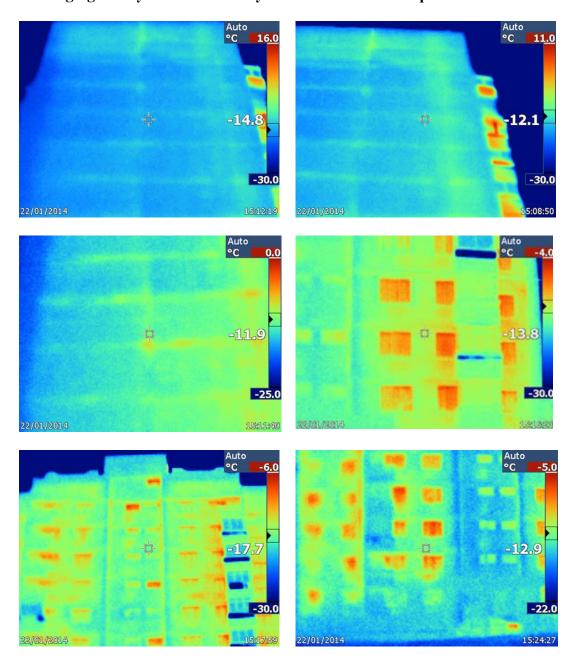
Thermal imaging survey data. 22 January 2014. Outdoor air temperature is minus 20 °C.

Thermal survey findings (Appendix 2) were used to calculate the actual building enclosing structures heat transfer resistance. Averaged wall external surface temperature is applied as the calculation input parameter.

Wall external surface average temperature is assumed to be equal to minus 17 °C.

Surveyed building enclosing structure design heat transfer resistance is $1.51 + 1.0 = 2.51 \text{ m}^2 \,^{\circ}\text{C}$ /W (rated design solution value is applied).

Surveyed building enclosing structure actual heat transfer resistance is over 2,51 m² °C /W.

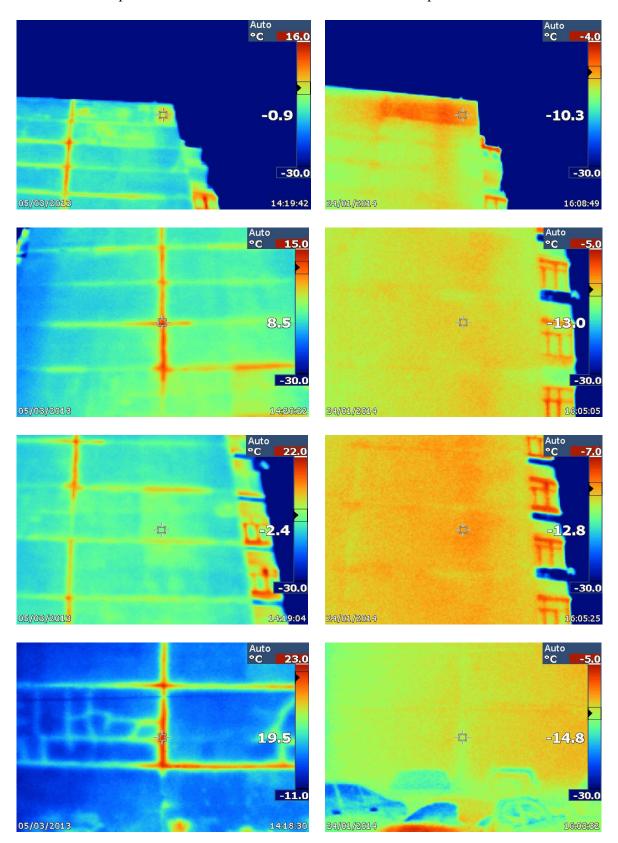
Outdoor air temperature is minus 20 °C.

After thermal insulation application (24.01.2014).Outdoor air temperature is minus 20 °C.

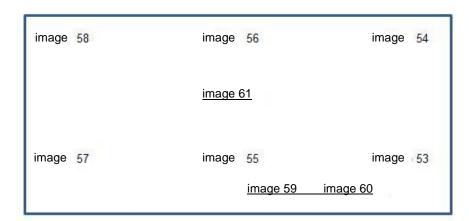
Before thermal insulation application (05.03.2013).

Thermal imaging survey layout.
